Coal Combustion Waste Impoundment

Round 6 - Dam Assessment Report

Vermilion Power Station (Site 015)

Fly Ash Dikes

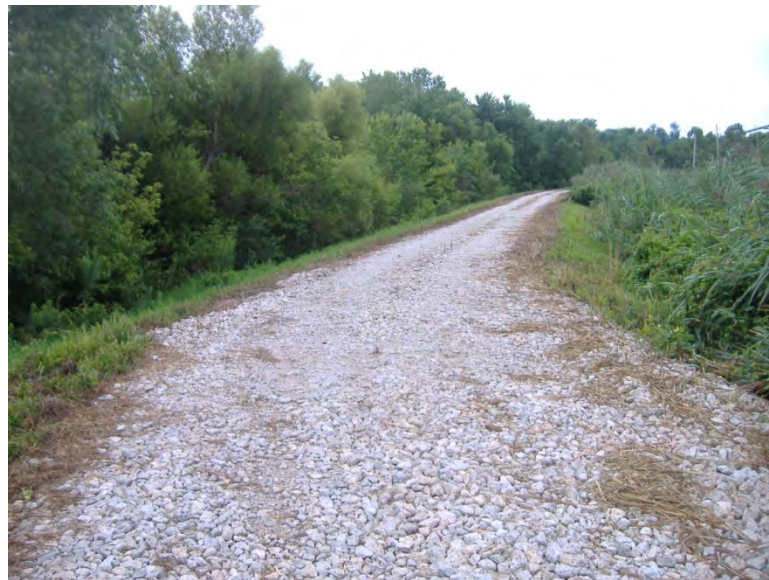
The crest of the embankment had no signs of significant depressions, tension cracks or other indications of settlement or shear failure. A gravel service road covered the majority of the embankment. Figure 5.2.1-1 shows the typical crest conditions.

Figure 5.2.1-1: Photograph of Crest of North Ash Pond System Embankment

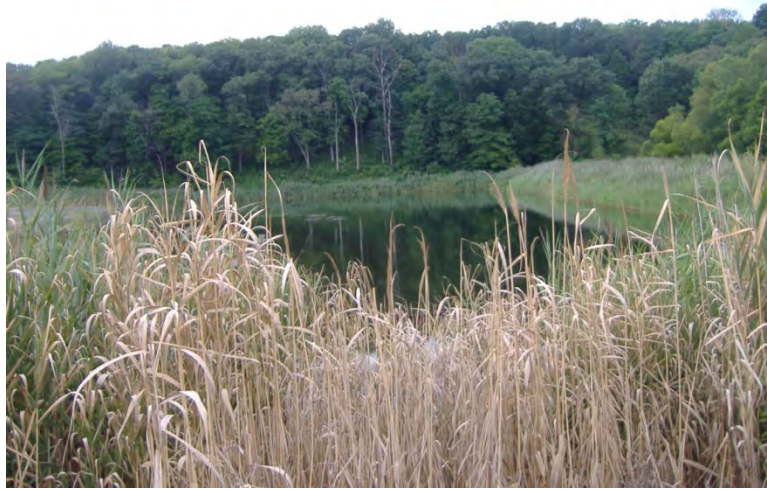
The inside slope of the North Ash Pond System embankment is vegetated with various species of tall grass and weeds. Heavy overgrowth in the primary cell of the North Ash Pond System made close observation of embankment conditions difficult. There were no observed scarps, sloughs, bulging, cracks, depressions or other indications of slope instability. Figure 5.2.2-1 shows a representative section of the inside slope of the primary cell embankment. Figure 5.2.2-2 shows a representative section of the inside slope of the secondary cell embankment.

Figure 5.2.2-1: Photograph of the Inside Slope of the North Ash Pond System Primary Cell Embankment

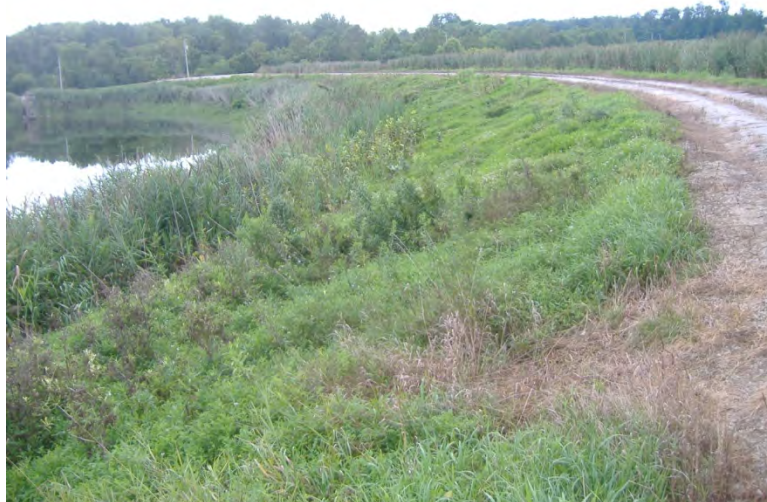
Figure 5.2.2-2: Photograph of the Inside Slope of the North Ash Pond System Secondary Cell Embankment

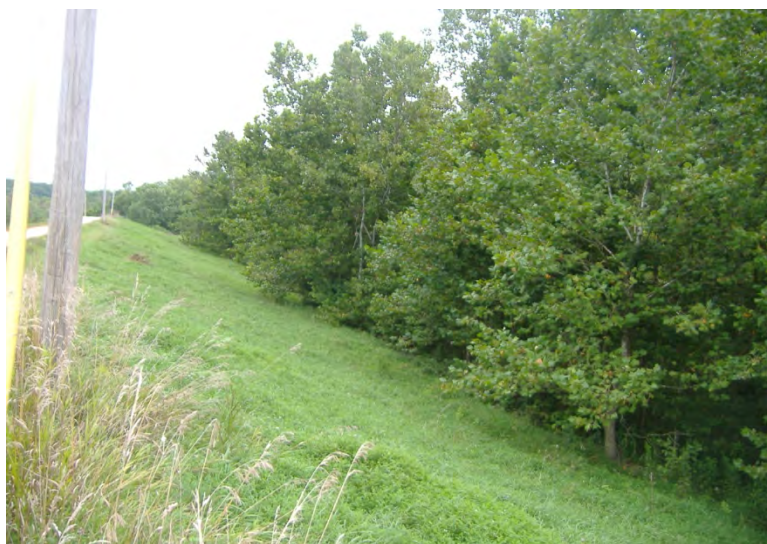
The outside slope of the embankment is vegetated with various species of tall grass and weeds. No major scarps, sloughs, bulging, cracks, depressions or other indications of slope instability, or signs of uncontrolled seepage were observed. Figure 5.2.3-1 shows a representative section of the outside slope of the embankment.

Figure 5.2.3-1: Photograph of the Outside Slope of the North Ash Pond System Embankment.

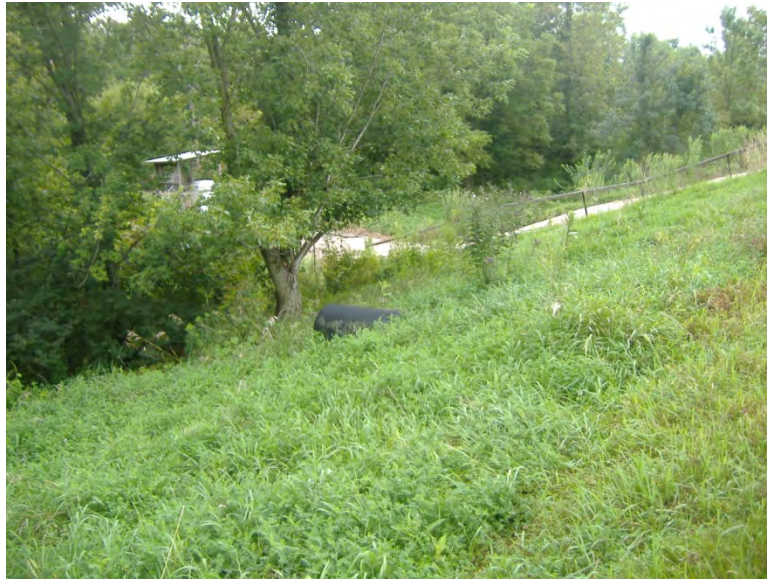
One large tree was observed near the emergency spillway of the North Ash Pond System. Figure 5.2.3-2 shows the tree.

Figure 5.2.3-2: Photograph of Large Tree Near Emergency Spillway on North Ash Pond System Embankment.

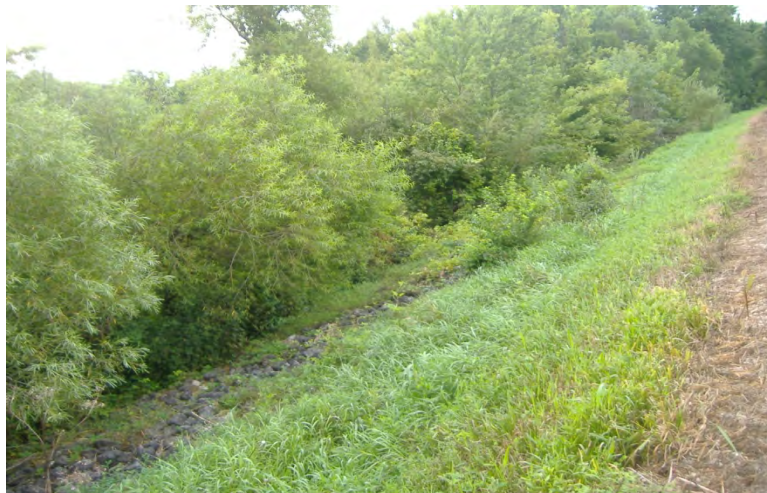
Most of the toe of the embankment is densely vegetated with various species of trees, grass, and weeds. In some sections, the toe is also armored with riprap. Figure 5.2.3-3 shows a portion of the toe that is armored with riprap and also covered in dense vegetation.

Figure 5.2.3-3: Photograph of Riprap and Dense Vegetation at the Toe of the North Ash Pond System Embankment.

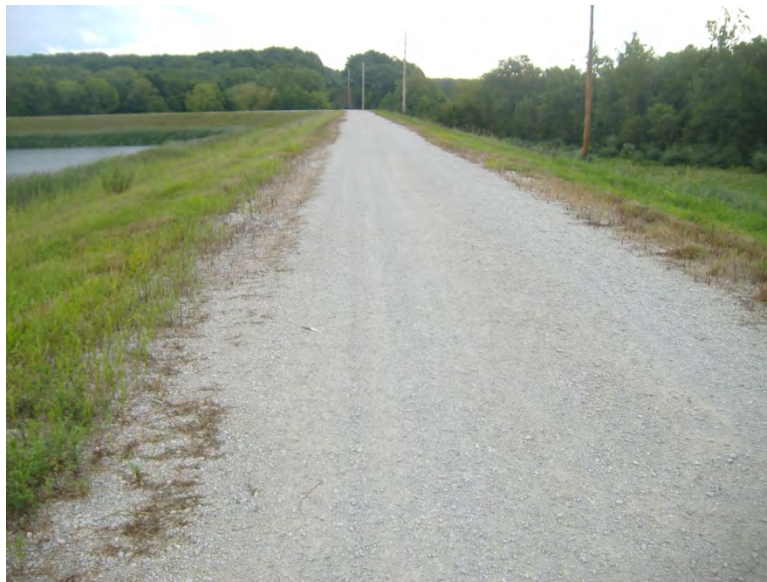
The crest of the embankment had no signs of significant depressions, tension cracks or other indications of settlement or shear failure. Figure 5.3.1-1 shows the typical crest conditions.

Figure 5.3.1-1: Photograph of the Crest of the East Ash Pond System Embankment.

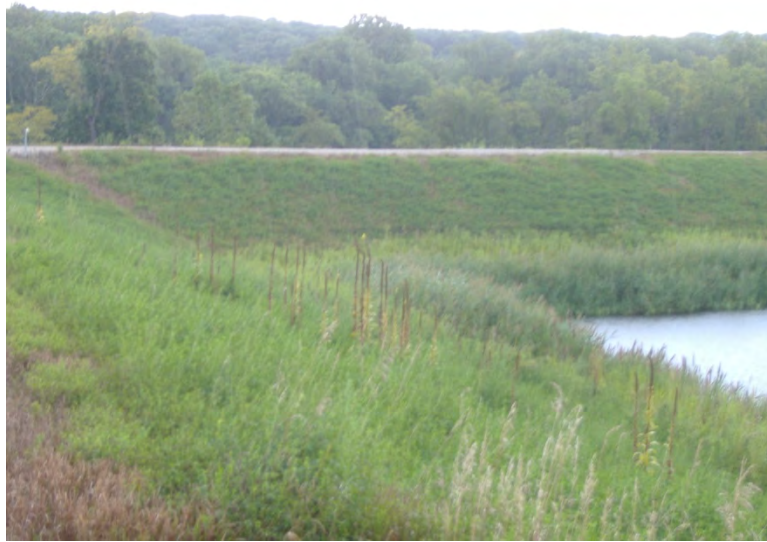
The inside slope of the East Ash Pond System embankment is vegetated with various species of tall grass and weeds. There were no observed scarps, sloughs, bulging, cracks, depressions or other indications of slope instability. Figure 5.3.2-1 shows a representative section of the inside slope of the primary cell embankment. Figure 5.3.2-2 shows a representative section of the inside slope of the secondary cell embankment.

Figure 5.3.2-1: Photograph of the Inside Slope of the East Ash Pond System Primary Cell Embankment.

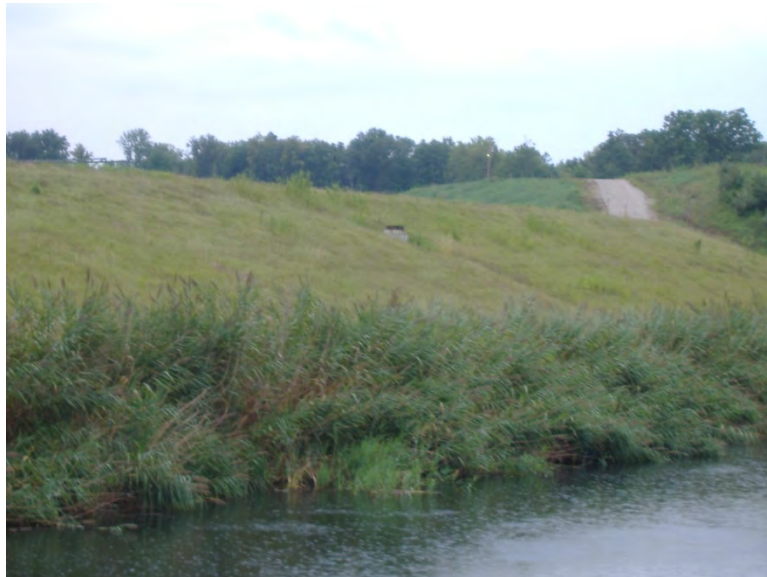
Figure 5.3.2-2: Photograph of the Inside Slope of the East Ash Pond System Secondary Cell Embankment.

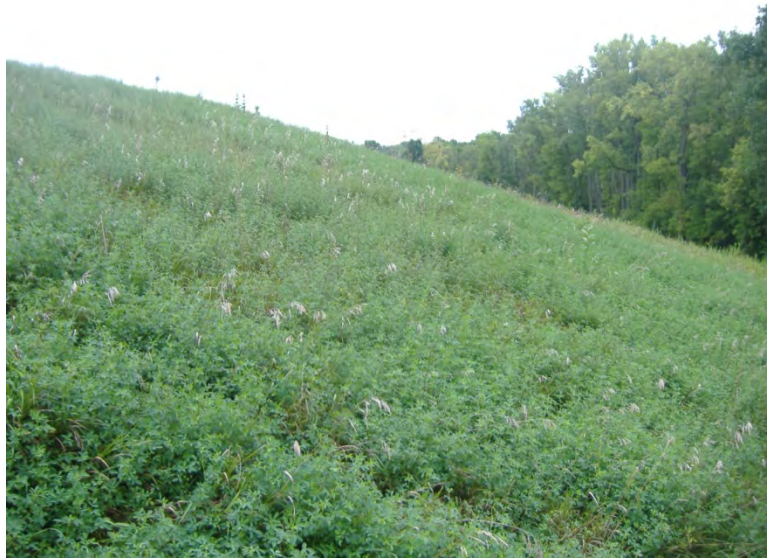
The outside slope of the embankment is vegetated with various species of tall grass and weeds. No major scarps, sloughs, bulging, cracks, depressions or other indications of slope instability, or signs of

uncontrolled seepage were observed. Figure 5.3.3-1 shows a representative section of the outside slope of the embankment.

Figure 5.3.3-1: Photograph of the Outside Slope of the East Ash Pond System Embankment.

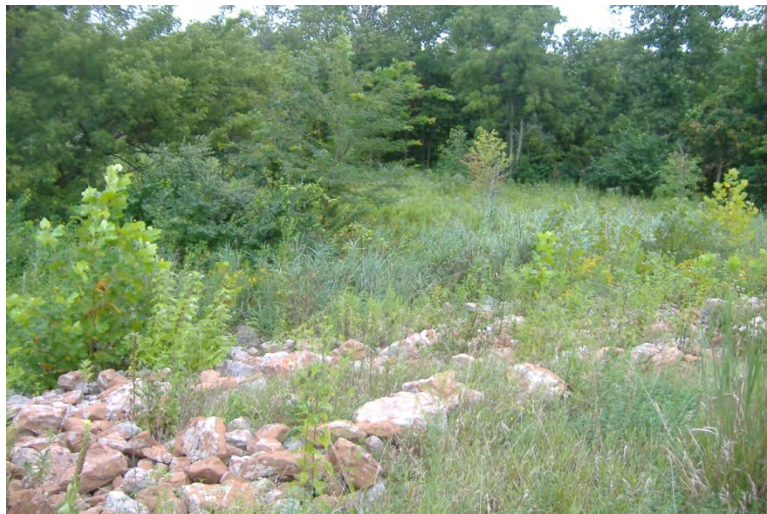
Most of the toe of the embankment is densely vegetated with various species of trees, grass, and weeds. In some sections, the toe is also armored with riprap. Figure 5.3.3-2 shows a portion of the toe that is armored with riprap and also covered in dense vegetation.

Figure 5.3.3-2: Photograph of Riprap and Vegetation at the Toe of the East Ash Pond System Embankment.

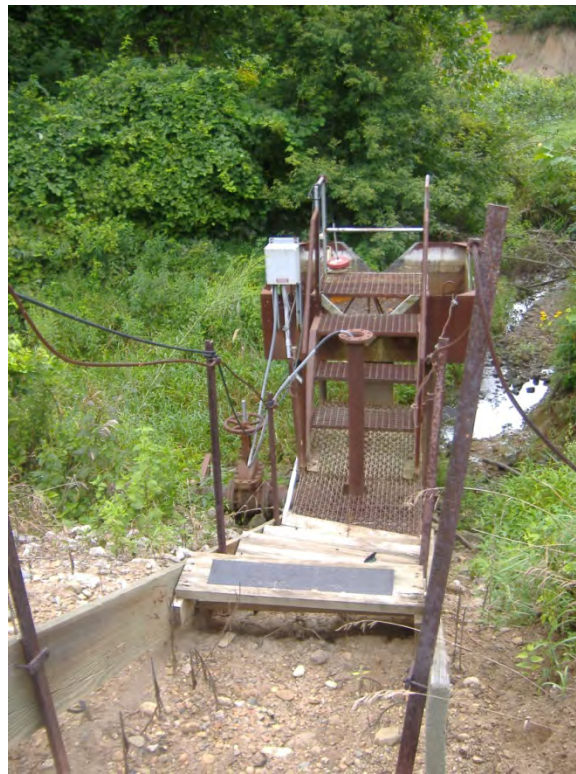
The North Ash Pond System overflow structure was observed to be working properly, discharging flow from the pond, and visually appeared to be in satisfactory condition. There was no sign of clogging of the spillway and the water exiting the outlet was flowing clear. Figure 5.4.1-1 shows the main outlet structure.

Figure 5.4.1-1: Photograph of the North Ash Pond System Overflow Structure.

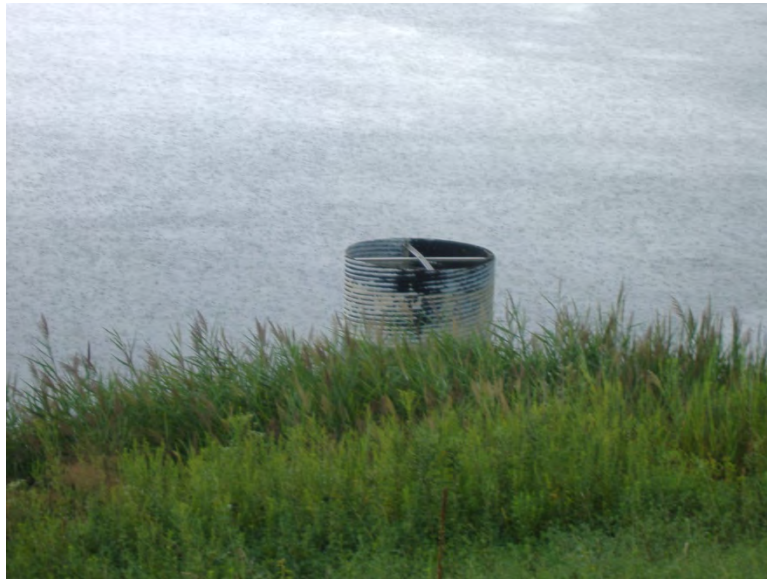
The East Ash Pond System overflow structure was observed to be working properly, discharging flow from the pond, and visually appeared to be in satisfactory condition. There was no sign of clogging of the spillway and the water exiting the outlet was flowing clear. Figure 5.4.1-2 shows the main outlet structure.

Figure 5.4.1-2: Photograph of the East Ash Pond System Primary Outfall Structure.

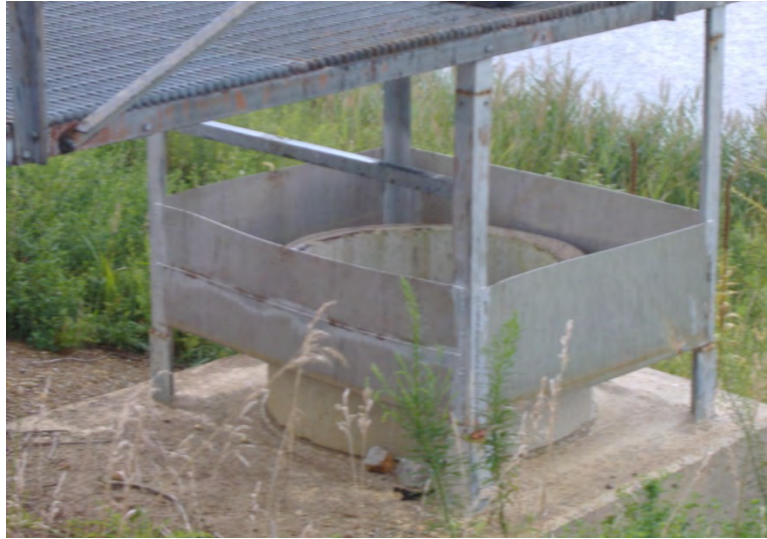
An emergency outfall pipe is present in the East Ash Pond System, directly below the primary outfall structure. Figure 5.4.1-3 shows the emergency outfall pipe.

Figure 5.4.1-3: Photograph of the East Ash Pond System Emergency Outfall Pipe.

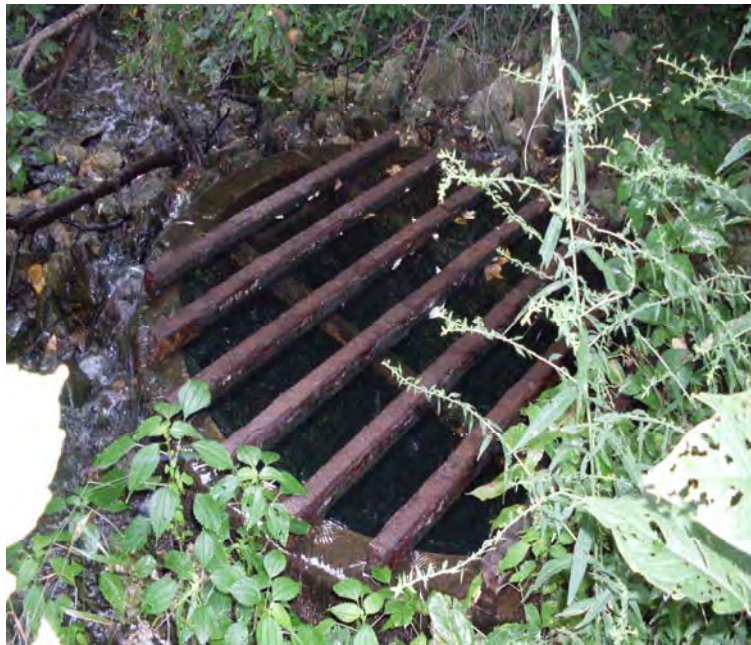
The outlet conduit appeared to be in good shape and operating normally with no sign of clogging and the water exiting the outlet was flowing clear. Figure 5.4.2-1 shows the spillway outfall pipe discharge.

The design of the spillway outfall pipe includes a vertical bend upward at the discharge end. The upward bend provides energy dissipation that reduces potential erosion along the receiving drainageway.

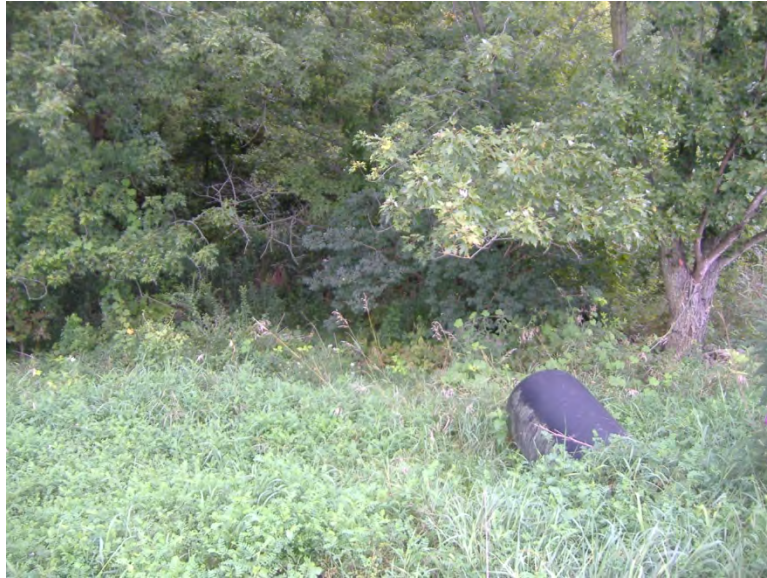
A corrugated metal pipe serves as the emergency spillway for the North Ash Pond System. The spillway has not been used in recent memory. Figure 5.4.3-1 shows the North Ash Pond System emergency spillway.

Figure 5.4.3-1: Photograph of the North Ash Pond System Emergency Spillway.
